FEDERAL TRANSIT BUS TEST

**Manufacturer: ARBOC SPECIALTY VEHICLES, LLC
Model: SPIRIT OF EQUUS**

**Tested in Service-Life Category
10 Year / 350,000 Miles**

Report Number: LTI-BT-R1803

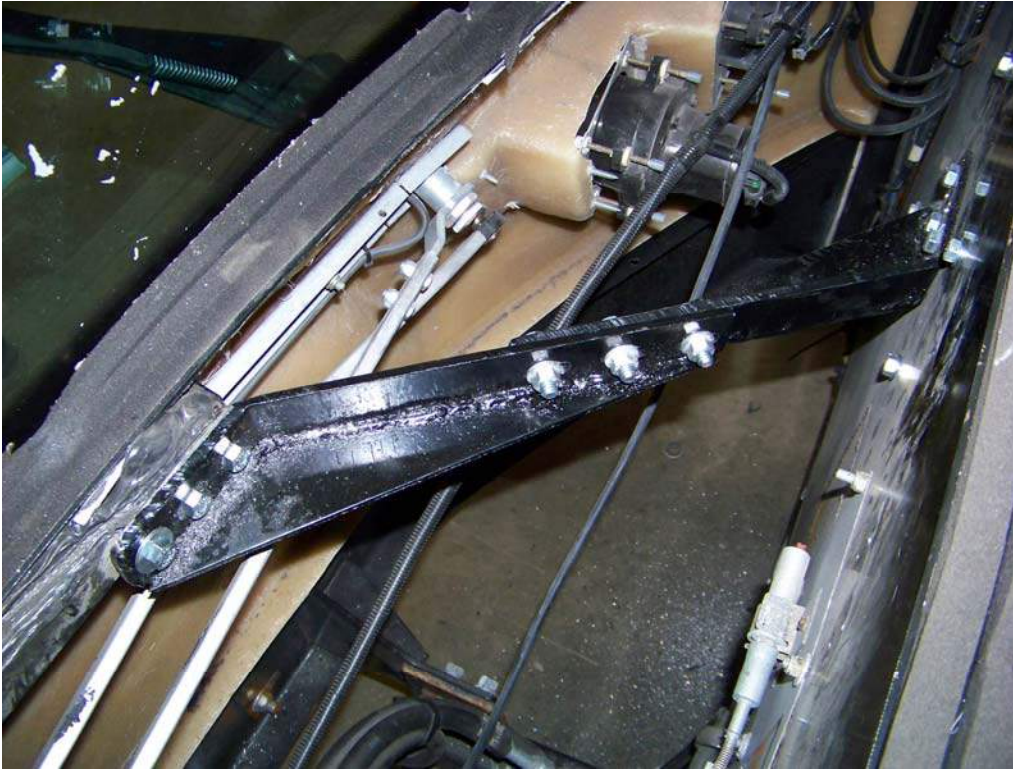
**LOWER WINDSHIELD SUPPORT ADDED AND REPAIRED
(1,254 TEST MILES)**

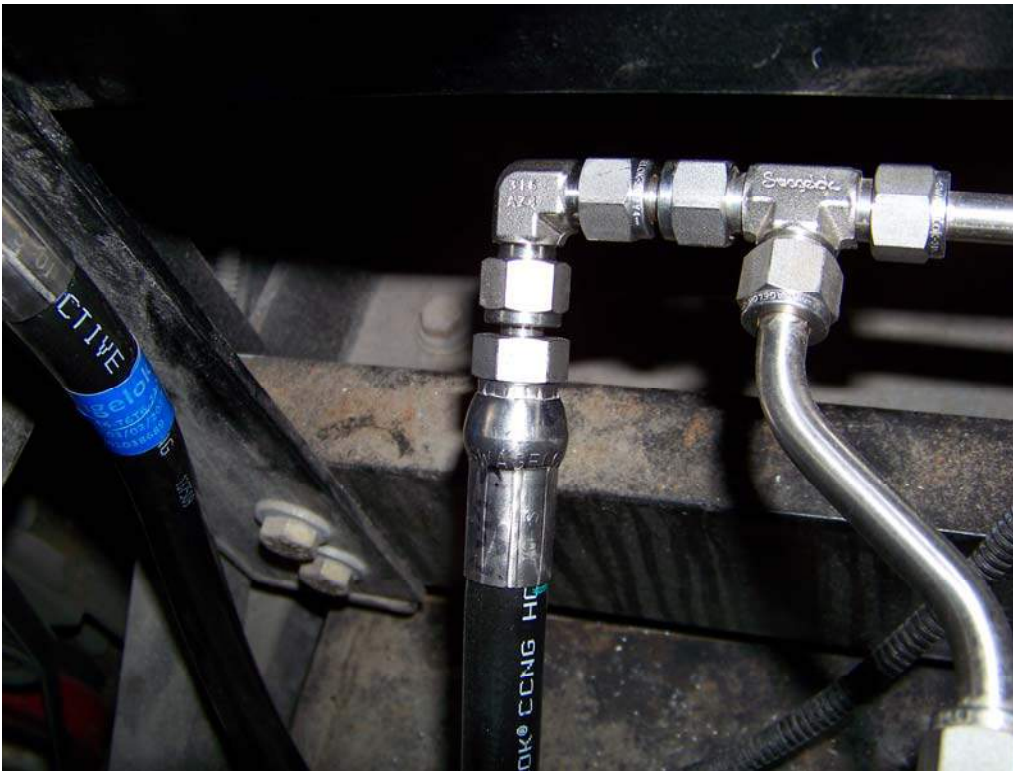
**FLEX CNG LINE INSTALLED BETWEEN TANKS AND
SUPPLY (1,487 TEST MILES)**

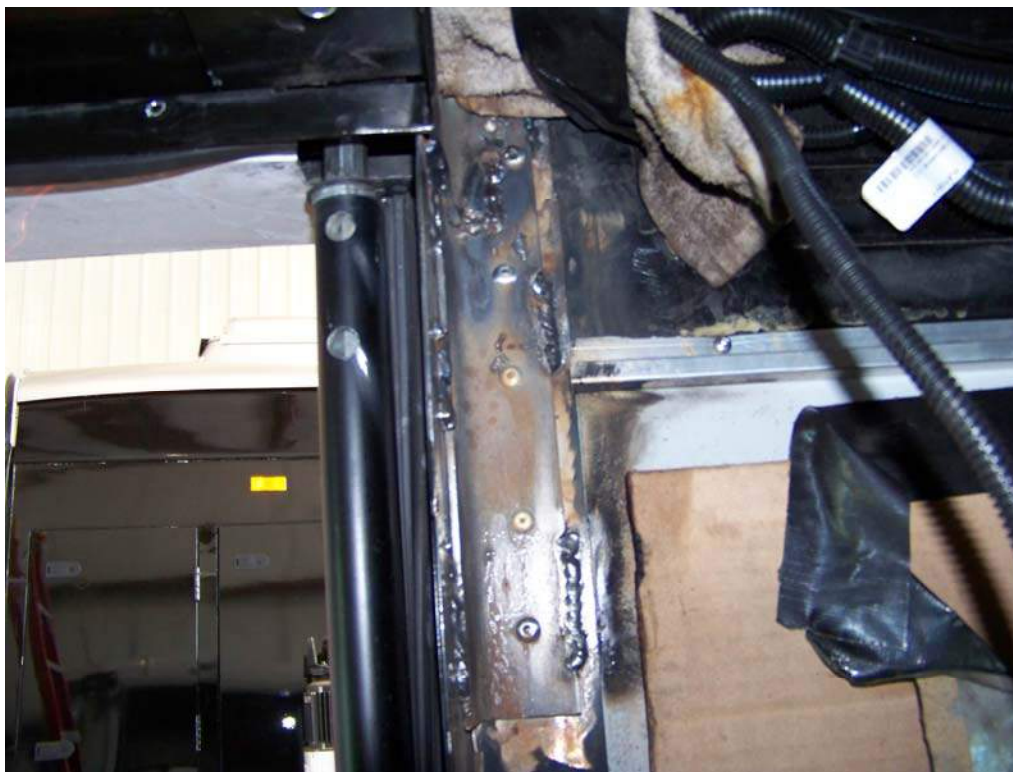
The FTA required the test bus to run an additional 1,813 miles at GVW at the end of the test to validate the correction of the Class 2 door failure which occurred on June 6, 2018. The additional miles were completed without any further failures relating to the door.

**DOOR FRAMEWORK REPAIRS
(5,724 TEST MILES)**

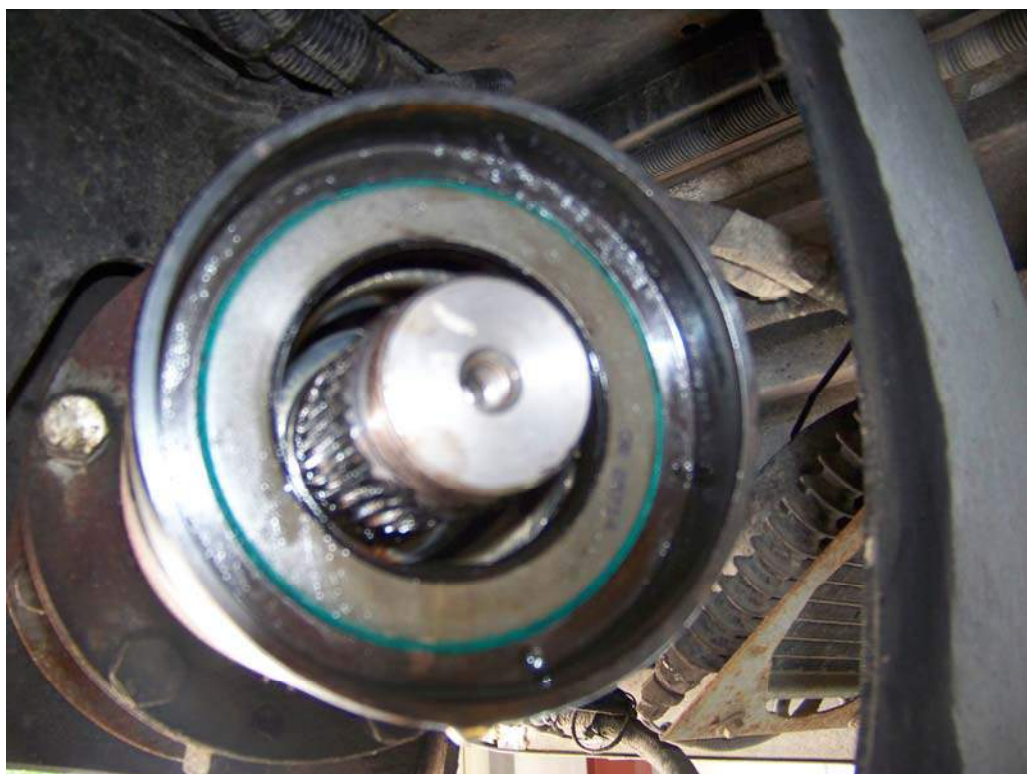
**OIL SEAL REPLACED ON GEARBOX
(5,787 TEST MILES)**

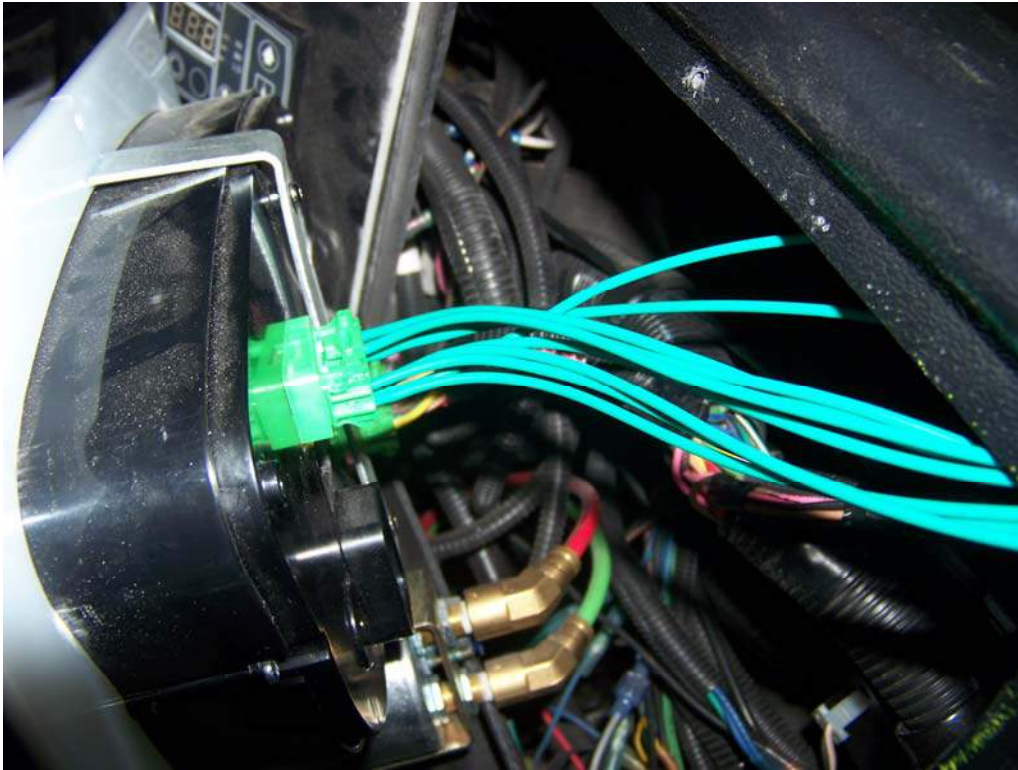
**DASH CLUSTER PLUG REPLACED
(7,129 TEST MILES)**

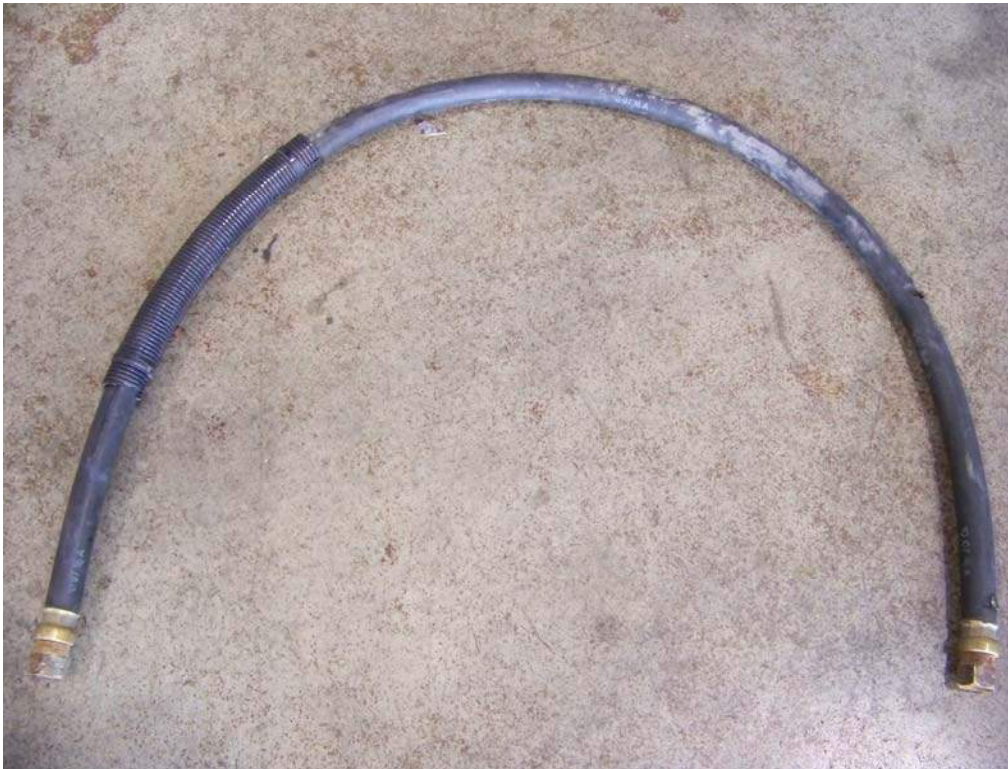
**FRONT BRAKE AIR HOSE LEAK DUE TO WHEEL
CONTACT (7,931 TEST MILES)**
